Manhole Inspection Summary

Manhole # S11II_046MH

Insp Date: **1/14/09 10:48 AM**

Location Address: **3020 HERBERT ST**

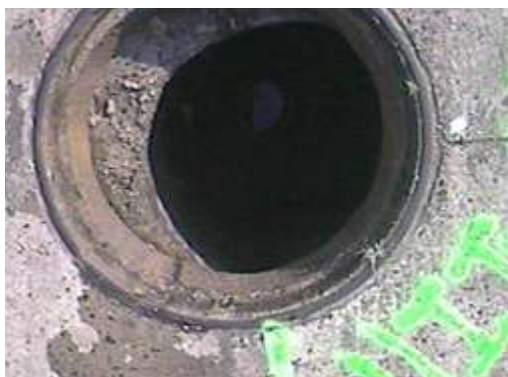
Defect 1

Frame Offset: **5** (in.) Condition: ☒ Sound ☐ Cracked ☐ Leaks

FRAME OFFSET

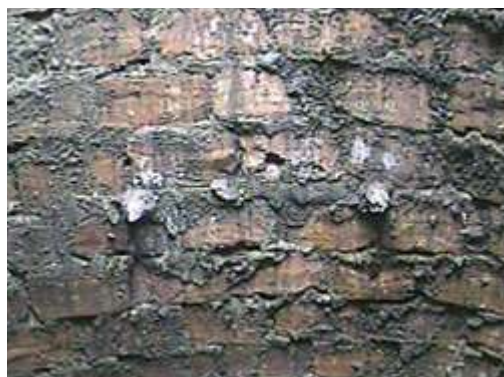
Defect 3

Steps Count: **5** Missing: **1** ☒ **Corroded**

MISSING / CORRODED RUNG

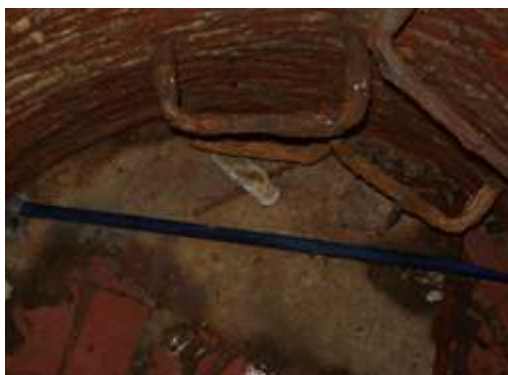
CORRODED STEPS

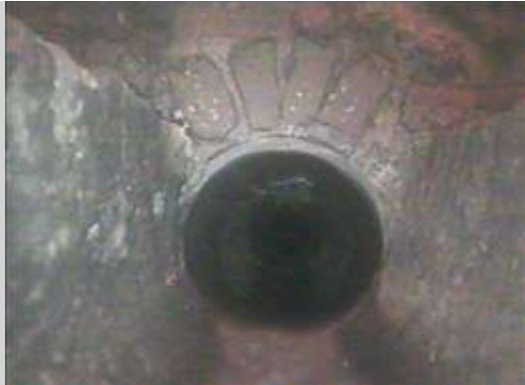
12 O'Clock Outflow

8 in. Circular Gravity Sewer
Pipe Out @ 12 O'Clock

Invert Depth: **9.19** (ft.) Flow Characteristics: **Slow**

Infiltration: **None** Pipe Seal Cond: **Unknown**

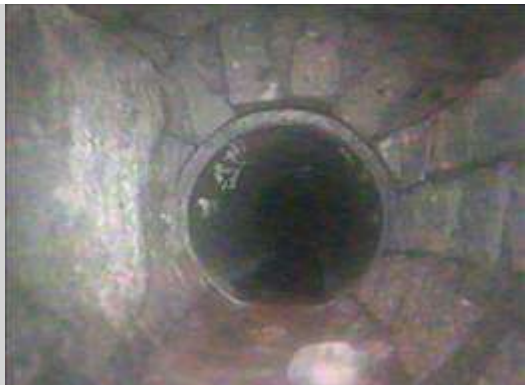
6 O'Clock Inflow

8 in. Circular Gravity Sewer
Pipe In @ 6 O'Clock

Invert Depth: **9.21** (ft.) Flow Characteristics: **Slow**

Infiltration: **None** Pipe Seal Cond: **Unknown**
